Part 1 – Merchant Vessels

Caution – Seabed Last Surveyed by Leadline in Mid 19th Century

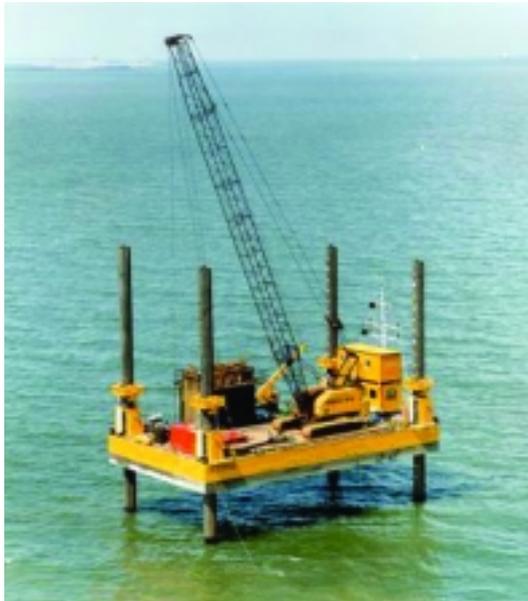
Figure 1: Jack-up barge in position

Shortly after altering course, and half an hour after low water, the barge grounded on the forward two, of her four, legs. The force of the grounding caused some of the barge personnel to fall; however, no one was injured.

The jack-up barge refloated 40 minutes after the grounding and was returned to harbour. All four legs were found to be damaged, with the damage to the barge costing an estimated £1m to repair. The delay in returning the barge to her destination also resulted in extensive delays to the project when the seabed frame, constructed during the previous installation stage, collapsed in the strong tides.

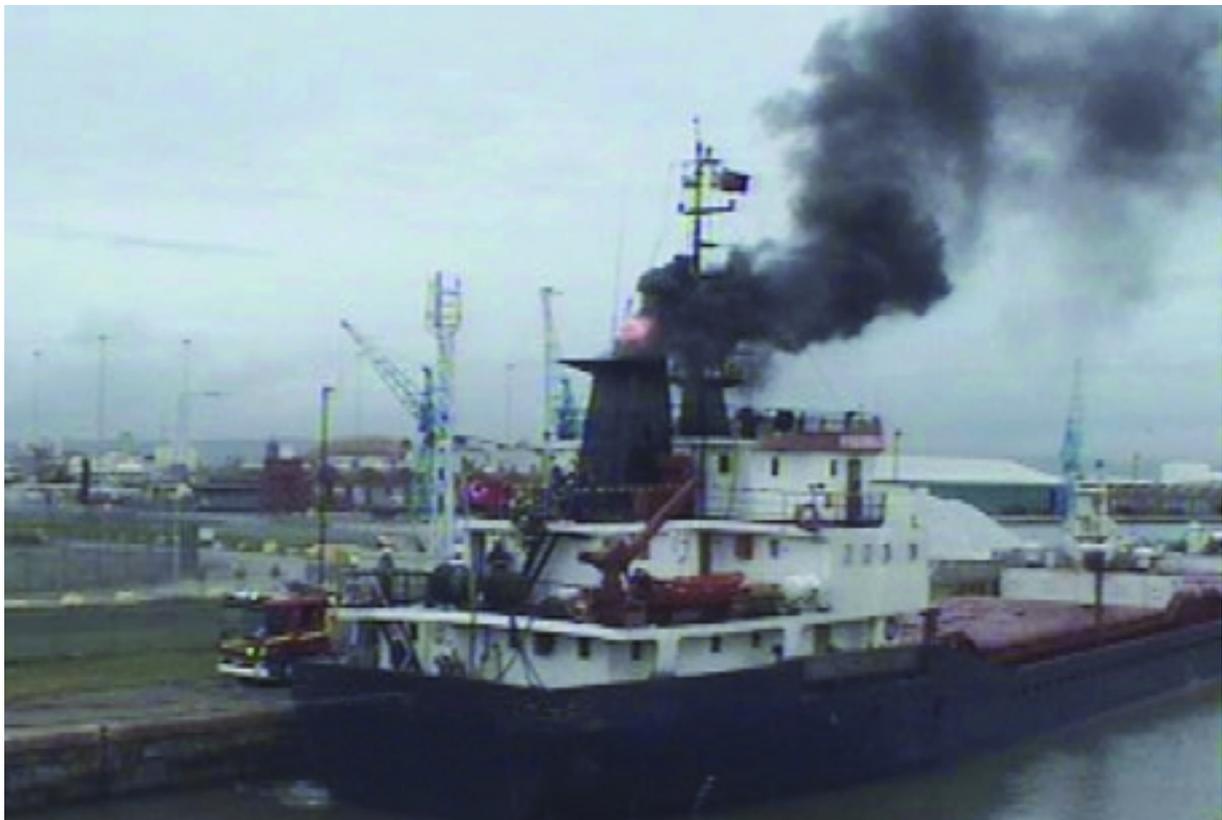
Figure 1: Fire Service attending to the fire (image captured from CCTV)

A 2500gt general dry cargo ship had arrived at a UK port following a passage from the eastern Mediterranean during which the ship had encountered particularly severe weather conditions. While manoeuvring in the locks, a fire occurred inside the upper part of the main engine exhaust uptakes, within the funnel area. Flames came out of the main engine exhaust at the funnel and ignited waste oil that was lying on the funnel top. This produced a spectacular ball of flames and much dense black smoke.

of the funnel. The engine room was evacuated, closed down and the CO₂ flooding system was operated without any problems. The fire was rapidly brought under control and was soon extinguished. There was some minor fire damage to both the internal and external paint finishes of the funnel and the lighting systems inside the funnel space.

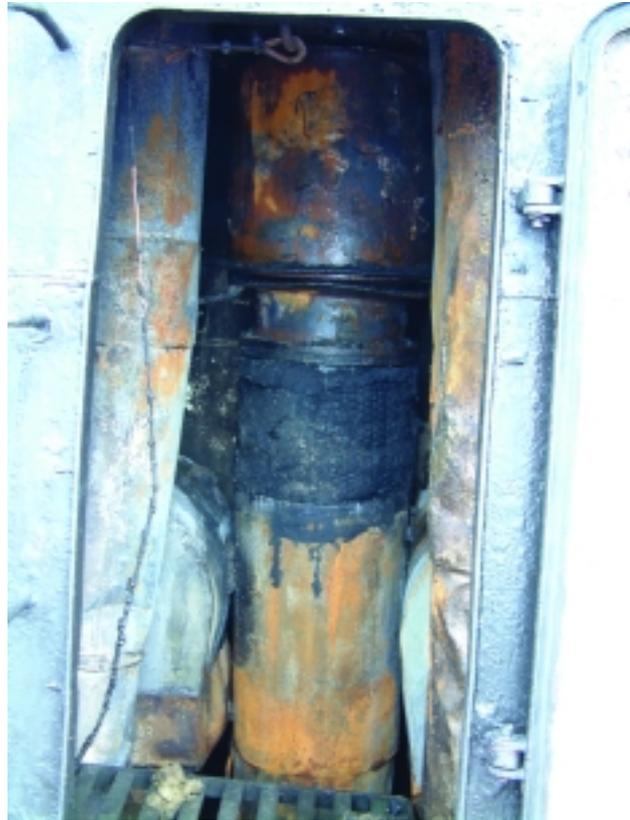
During the evening, there was a second, smaller incident. Increasing amounts of smoke were seen coming from the upper part of the funnel, in the area of the main engine silencer/spark arrestor. The local fire brigade was called again, and returned on board and located the seat of the fire. Hot spots remaining inside the main engine exhaust from the first fire had ignited the oily/greasy

Figure 2: The main engine/silencer arrester – the seat of the second fire

vapour residues in the mineral wool insulation that covered the exhaust uptakes. This second fire was extinguished by breaking open the outer metal cladding and applying water directly to the seat of the fire within the insulation itself. A small amount of water was also put down the exhaust uptake, care being taken to allow this to drain off before it reached the main engine.

3. The phenomenon of fires within oil contaminated lagging is well known, and is commonly labelled a “*lagging fire*”. In this case, although covered with thin metal sheathing for mechanical protection, the mineral wool insulation was not vapour-sealed. The oil contamination was probably due to oily vapours inside the funnel space condensing on the outside of the exhaust trunking as it cooled. These owners now have a planned programme of inspection and renewal of contaminated lagging. Do you know what is inside your lagging?

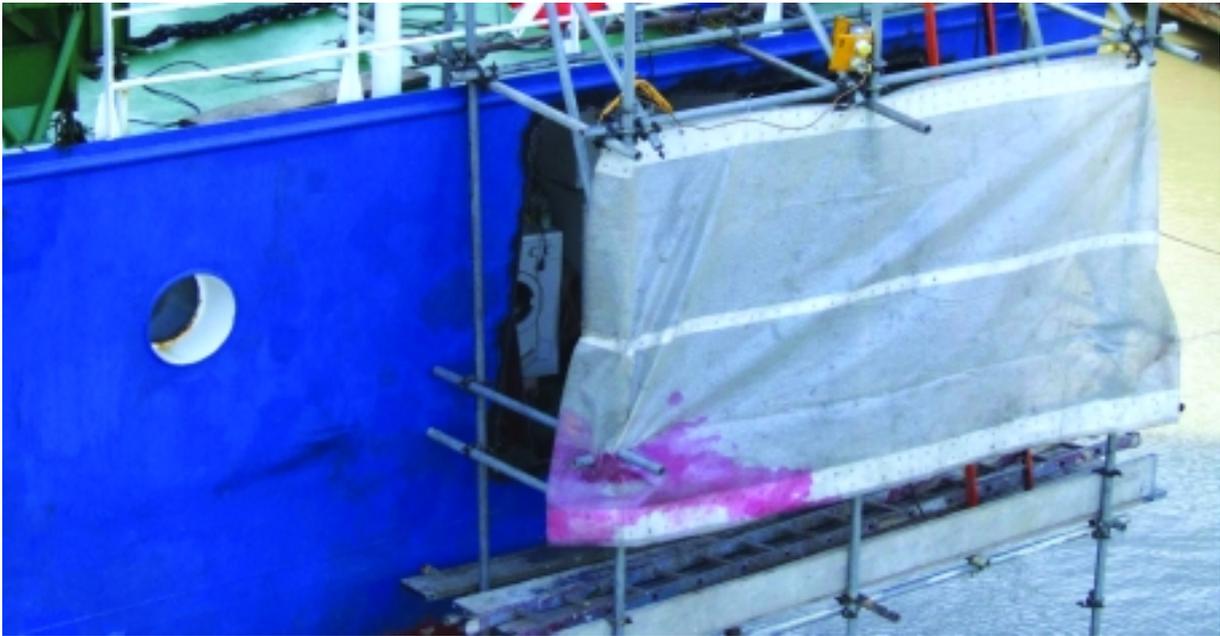
Figure 2

The cargo ship was holed above the waterline (see Figure 2) and diverted to a nearby port for survey and repair, but the trawler sustained only superficial damage and continued fishing.

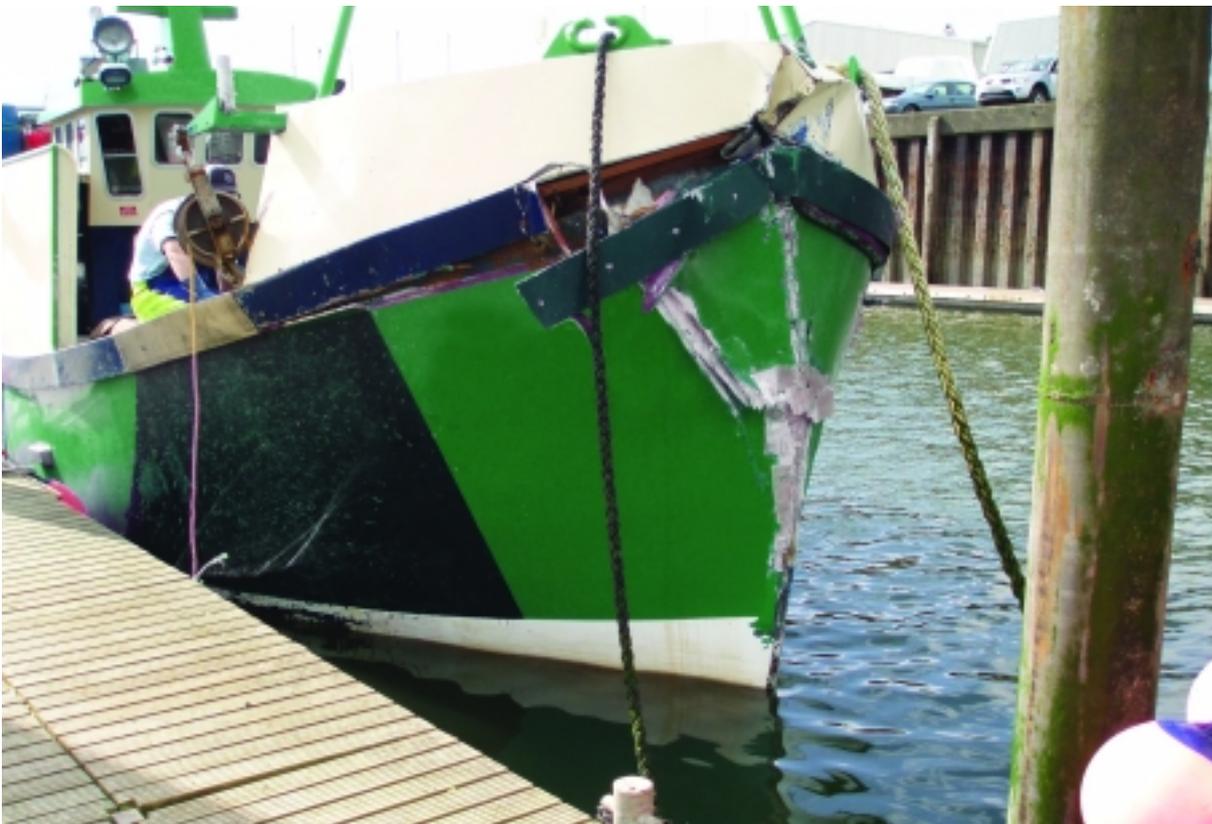
As a result of the collision, the tanker suffered some superficial damage, but the fishing vessel was damaged more substantially and was able only to limp into port with her bilge pumps working (see photograph).

Damage to the fishing vessel

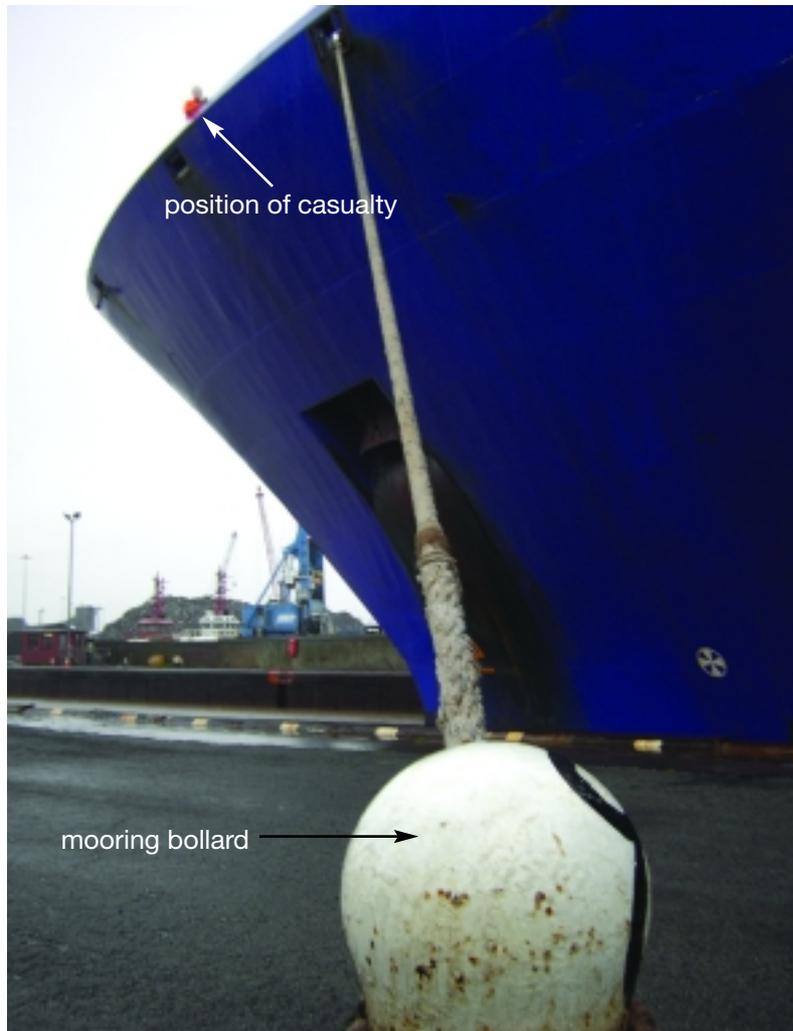
Figure 1: Mooring arrangements at the time of incident

The forward 64mm backspring was passed down to two linesmen. The senior linesman, who was a berthing master and unfamiliar with this specific task, placed the eye of the mooring rope over the allocated bollard, *without* using a hitch. Both linesmen then moved towards the inner gates to operate the machinery controlling the sluices. When the ship was in position, the forward backspring was heaved in to hold the ship. The leading hand took over from the able seaman at the

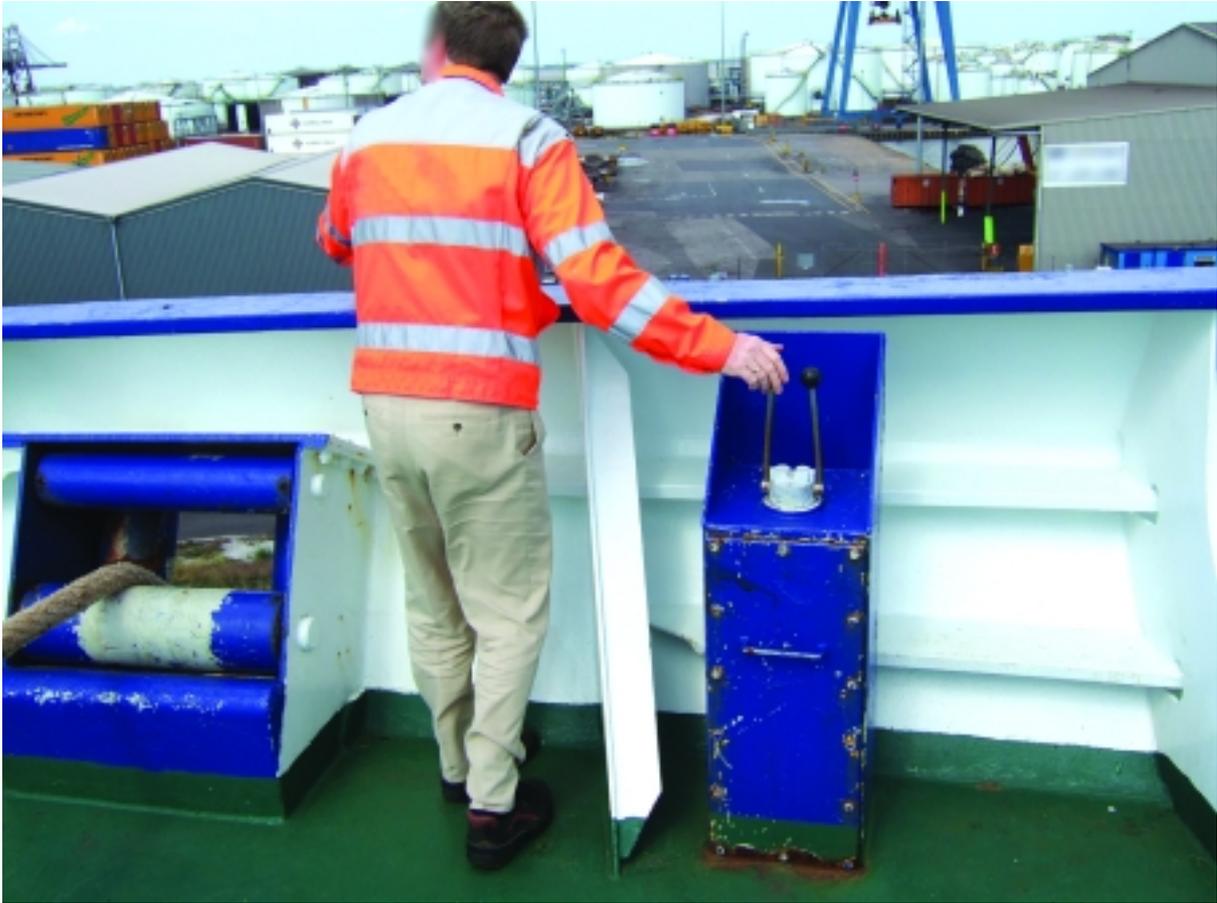
Figure 2: Position of casualty at controls

winch controls, which were located at the ship's side, next to the fairlead through which the backspring passed. As the ship rose in the lock, the backspring slipped off the bollard,

snapped back, and struck the leading hand in the face, causing lacerations and fractures to his cheek bone and nose. He had not been wearing a safety helmet.

2. It is essential that all personnel involved in mooring operations are provided with, and wear, personal protective equipment.
3. Complacency is a killer, and it is vital that ships' staff keep alert to the potential risks involved in mooring operations at all times.

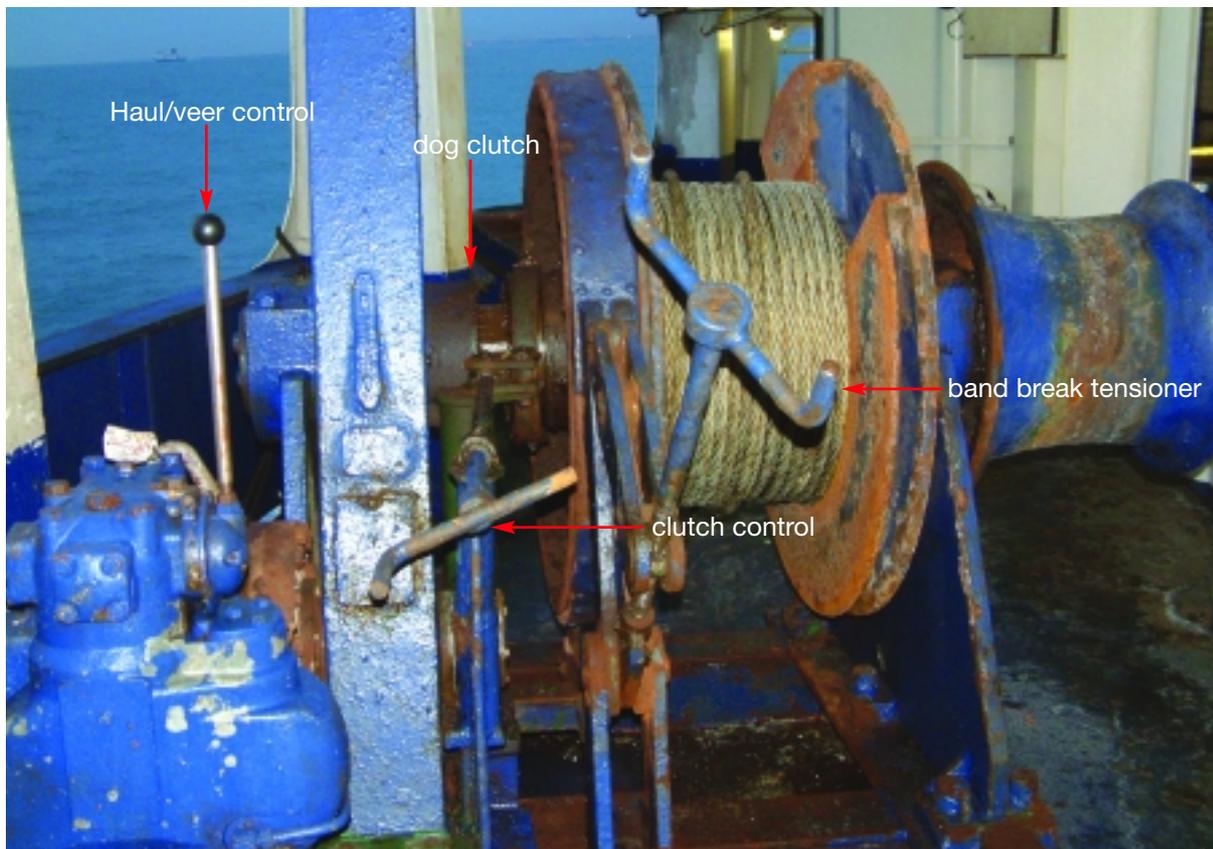
Figure 1: After winch mechanism

The forward and after mooring ropes were secured in different ways: the forward mooring party used ropes on bights and left them on the winch warping drum so that rope tension equal to that of the wire could be achieved. The ropes were then backed up on bitts, with figure of eight turns. The after mooring party also used ropes secured on the drum ends, but without using bights. They were backed up with only a couple of turns around a single bitt.

1. Moorings should always take due account of the existing and predicted weather conditions.
2. Short lengths of line (nips) and mixing of wires and ropes for the same service i.e. for breast, head/stern lines should be avoided.
3. Masters should encourage positive reporting from the mooring decks, with a clear description of the moorings and status of winches.
4. The tie up should be supervised, where possible, by an officer, as laid out in STCW Chapter 25.
5. Ropes should be removed from winch warping drums and secured on bitts using figures of eight, using stoppers as appropriate.
6. Do not assume that moorings which cannot be seen are as satisfactory as those which are visible – do check; the effort is worth it.

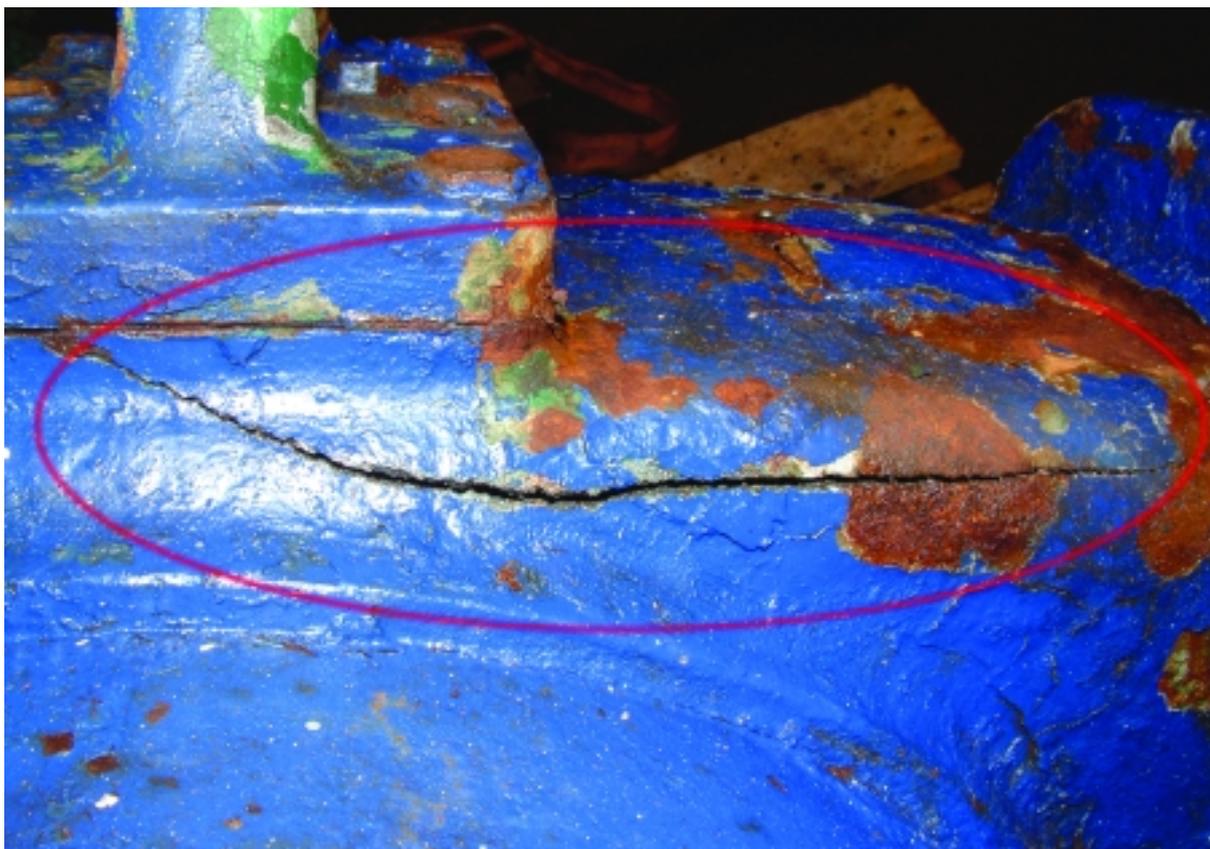
Figure 2: Fractured motor casing

As weight came onto the after ropes the loose turns were pulled from around the single bitts, and the winch warping drum rotated which, in turn, rotated the winch hydraulic motor backwards. This huge shock loading pressurised the motor casings and they fractured under the excessive pressure (Figure 2), spraying hydraulic oil across the port after winch deck.

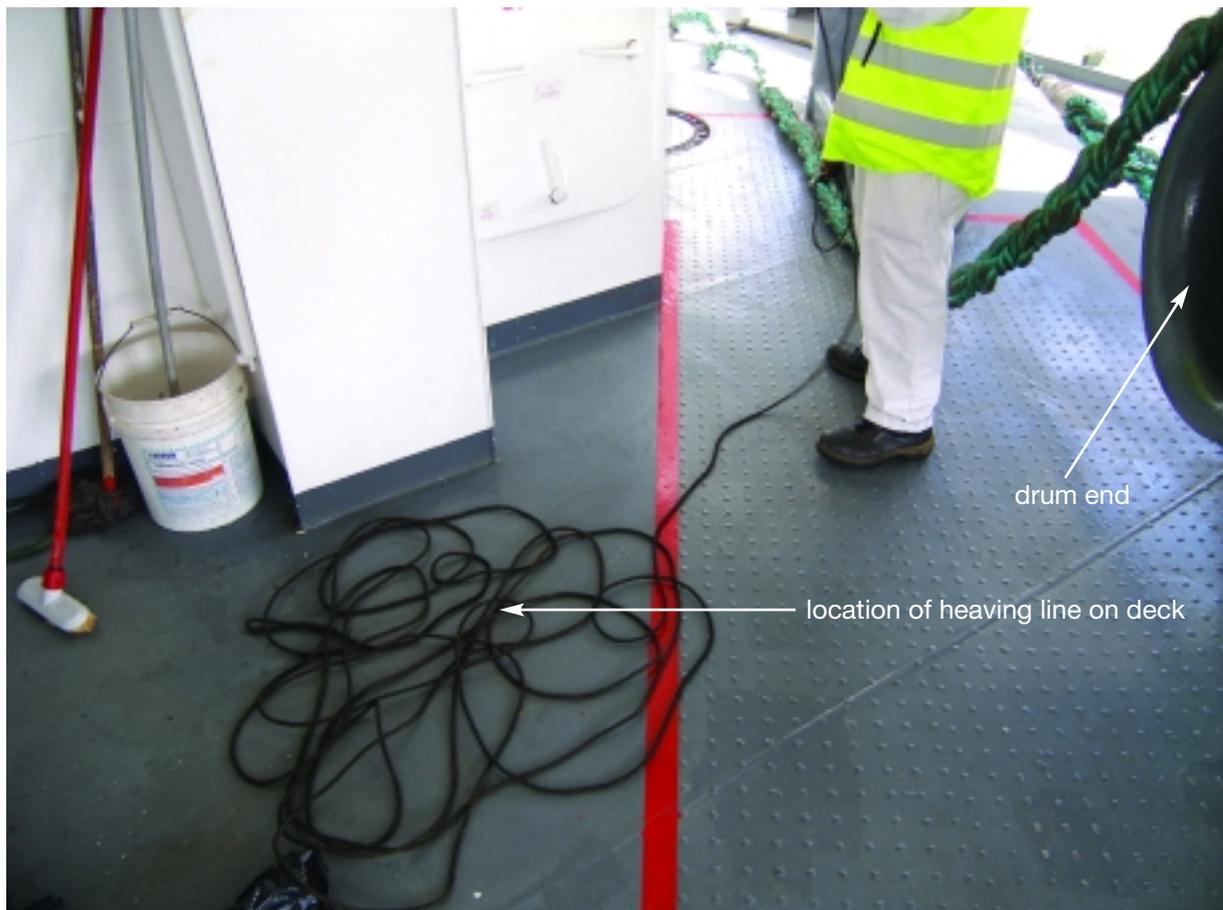
Figure 1: Position of the casualty in relation to the heaving line

As the tow wire neared the panama eye, the tug unexpectedly started to move off to port and away from the stern of the ship. Although the tug's tow wire was veered by the crewman on the tug's aft deck, and heaving was stopped on the ship's aft deck, the messenger line started to pull off the ship's drum end. The seaman near the drum end saw a riding turn starting to form and he stepped in to clear it, standing on the heaving line which was still attached to the messenger line as he did so. His left ankle became caught in the heaving line and, as the last turns of the messenger slipped off the drum end, he was pulled towards the panama eye.

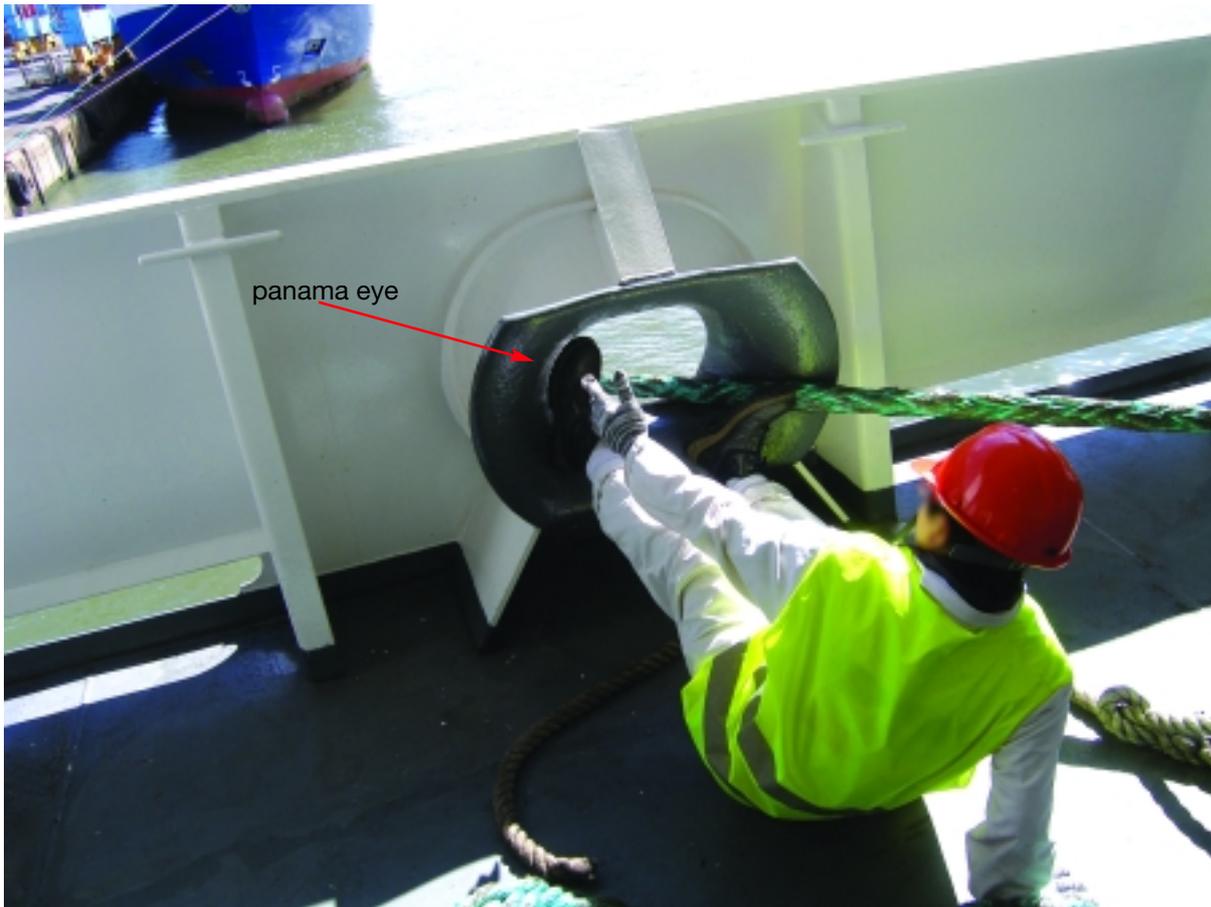
Figure 2: Position of the casualty before being dragged through the panama eye

The crewman braced himself against the panama eye while his fellow crew members tried to clear the heaving line. Just as the officer-in-charge took two paces to retrieve a knife from the galley, the seaman, concerned at losing his leg, decided to put his feet and legs together and, miraculously, was pulled through the panama eye (see Figure 2).

2. Making a tug line fast to a ship presents a significant hazard to both ship and tug crews. It is important to remember that tugs, operating in the wash of a ship can, and do, occasionally lose control temporarily, causing them to move off station. Ships' crews must be prepared for this, and must be able to respond quickly and effectively to reduce the risk of serious injury.

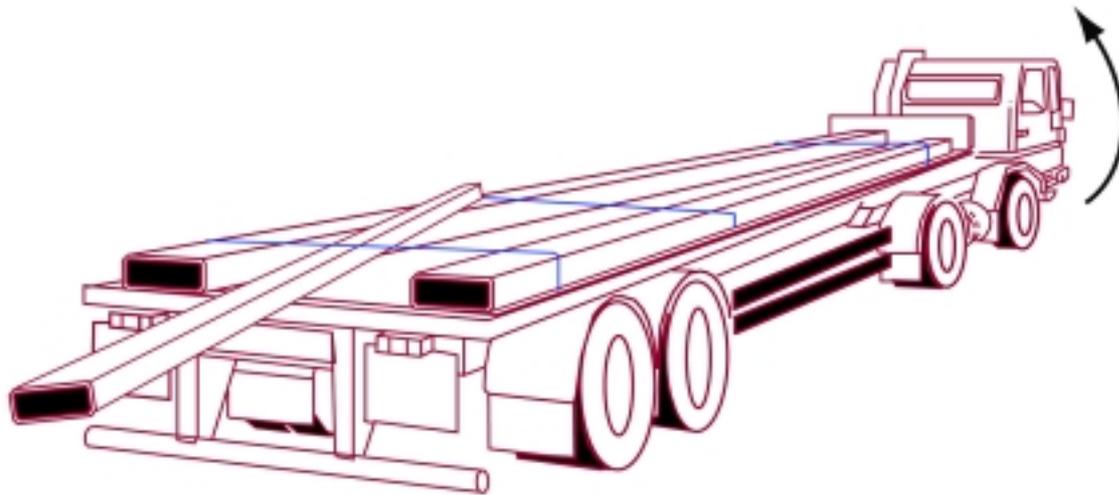
The crew heard a loud bang and went to see what had happened. Part of the load of steel box-sections had slipped off the rear of the trailer and landed on the deck of the ship. Fortunately, the area immediately behind the trailer was clear, no one was injured and only very minor damage was caused.

The load of steel box-sections was inspected and found to be made up of full and half lengths. It had been secured using several webbing straps across the width of the trailer. Forward movement was prevented by the headboard at the front of the trailer, but there was only the friction from the webbing straps to prevent the steel from sliding rearwards. The sections that slipped off the trailer were half lengths, from the middle of the load where the webbing straps would have had the least effect.

1. Crew working on vehicle decks should be aware of the correct lashing methods used to secure common loads to trailers. Advice is freely available from Government Departments and Industry Associations on best practice.
2. Trailers should be inspected where possible to ensure that both the load and the trailer are secured when they are loaded on board the vessel.
3. Personnel should keep clear of the area around vehicle trailers when they are being lifted or moved, to minimise the hazard should any items fall.
