Part 1 – Merchant Vessels

Caution – Seabed Last Surveyed by Leadline in Mid 19th Century

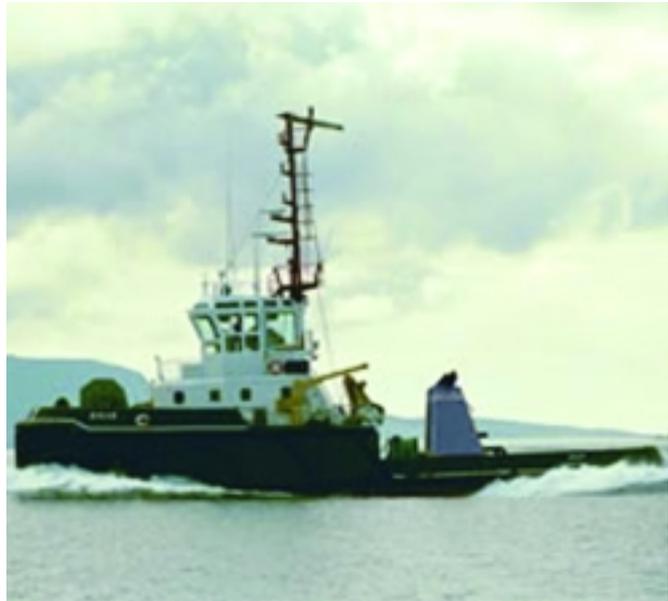
Figure 2: The tug used to escort the jack-up barge

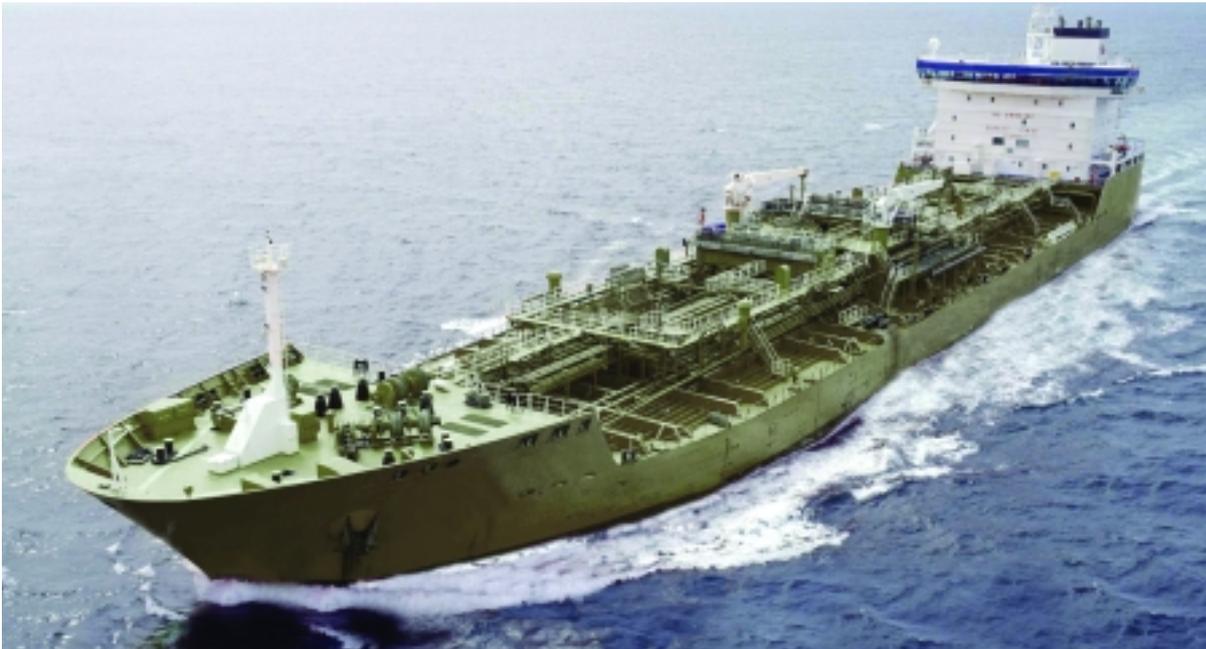
A chemical tanker had discharged parcels of cargo at a port in the Middle East and was outbound through a narrow channel to sea. With the pilot on board and an escorting tug alongside, all was going well. In good weather conditions and an ebbing tide, the pilot decided to disembark at the port's breakwater, about 3 miles short of the official position. This was just before the channel turned through 90 degrees to port and reduced to a width of 1.5 cables. Despite this, the tug was dismissed and the pilot disembarked.

The tanker came to rest with the forward part aground on soft sand/mud, and the fishing boat passed down its starboard side without making contact. Although the fishermen jumped into the water, they were thrown lifebuoys and were recovered unhurt. The tanker was later refloated with the assistance of a tug. With no damage evident from tank soundings, the vessel was allowed to continue on passage.

1. The pilot disembarked significantly ahead of the official boarding position, immediately prior to a difficult manoeuvre in complex tidal conditions and left without giving any further advice.
2. The master allowed his vessel to move to the port side of the channel, despite the requirements of COLREGs and the presence of the small boat ahead on the port side.
3. The master did not monitor the helmsman's response to his orders and was not aware of the large amount of port rudder until it was too late to rectify the situation. The helmsman applied maximum port rudder without further instructions from the master.
4. Although speed had been increased, the following tidal stream significantly reduced the effect of the rudder.
5. Despite members of the bridge team completing resource management training, the lessons learned were not applied on this occasion.

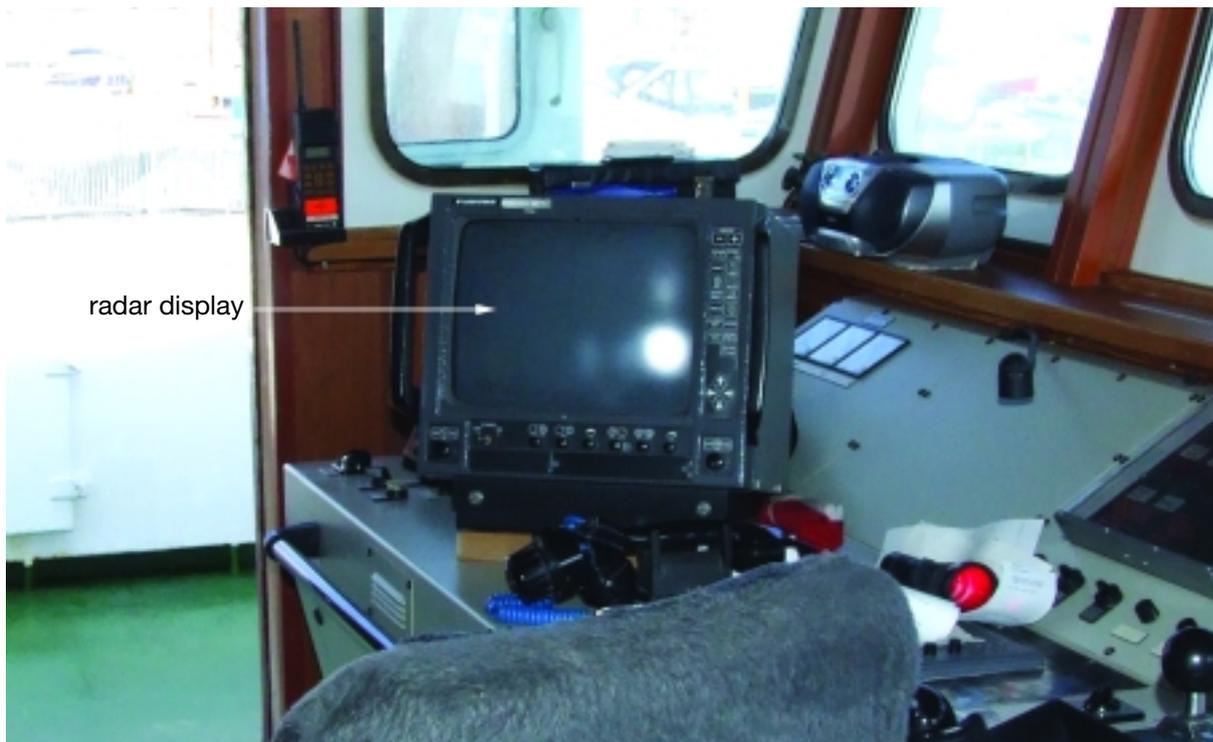
Figure 1

A 1568gt general cargo ship in ballast was on passage through UK territorial waters on a course of 007° in autopilot, and making good a speed of 7 knots. The wind was from the north, force 7, and the sea was rough with a swell of between 2 and 3 metres. Fifteen minutes after taking over the bridge watch from the master, the chief officer saw a beam trawler off his port bow at a range of 2 miles. The fishing vessel had also been seen by the master shortly before handing the watch to the chief officer, but he had not assessed her CPA or notified the chief officer of her presence during the watch handover. The chief officer saw that the vessel was fishing and, by using the EBL on the radar display, assessed that she was on a steady bearing. The radar display in use (see Figure 1) did not have a gyro input and was not equipped with an automatic or semi-automatic plotting facility.

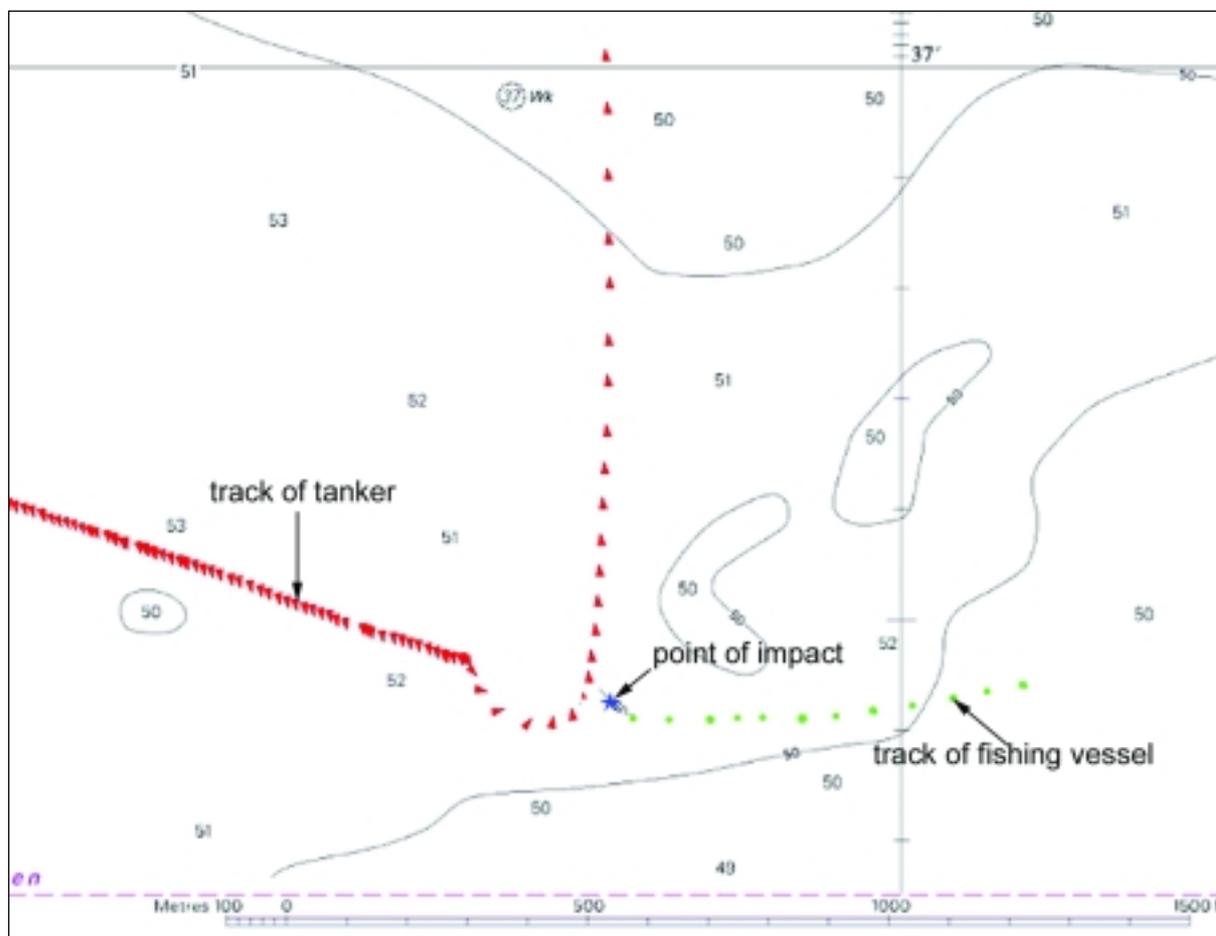
At about 0848 UTC the master of the tanker received a call from the pilot advising him to meet him at a position 2 miles to the north. He plotted his position at 0850 UTC and manoeuvred his vessel to head north with the use of helm and engines, acquiring a speed of about 3 knots in so doing (see Plot). At the time, the bridge was manned by the master and a seaman.

Tracks of the vessels

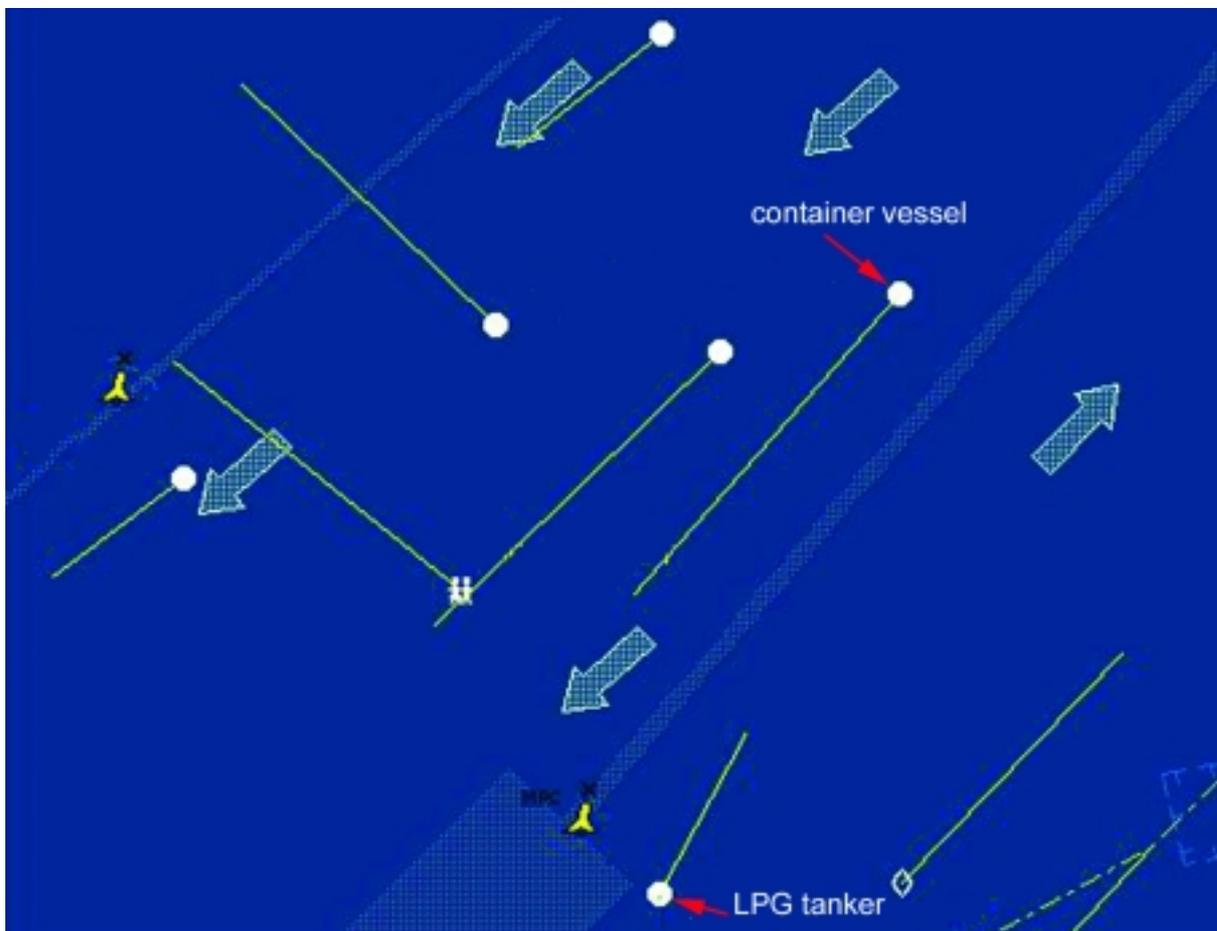
There was a strong tidal stream running from the north-east, so the vessel was a little later arriving at the MPC buoy than expected. At the MPC buoy the lookout took the wheel and, on instruction, altered course to cross the south-west lane. After steadying on the new course the OOW fixed the position using a visual bearing and radar distance, and plotted it on the chart in the chart room. He recalls seeing the target vessel, a container ship, broad on

Figure 1: Initial position of vessels

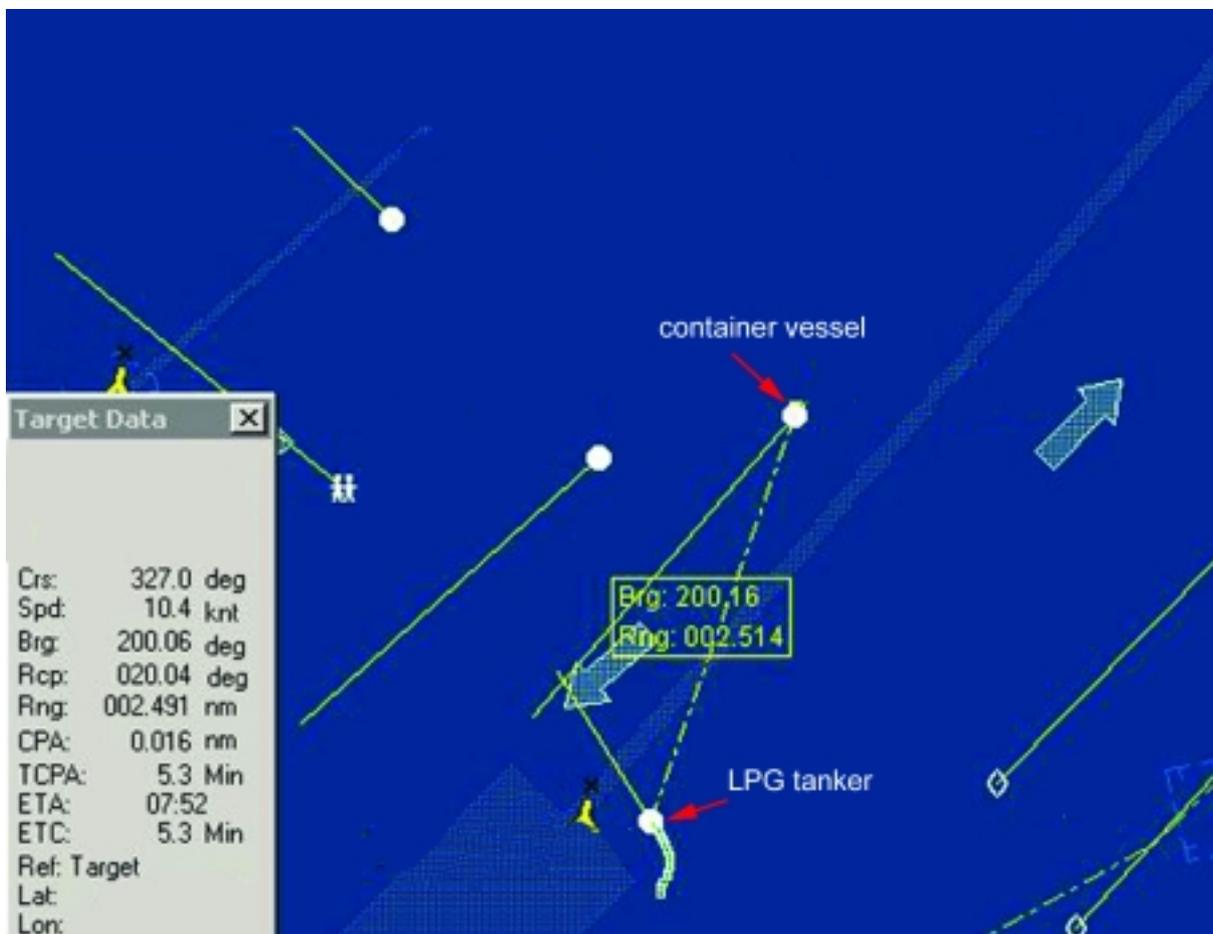
Figure 2: Vessel positions after LPG tanker's change of course

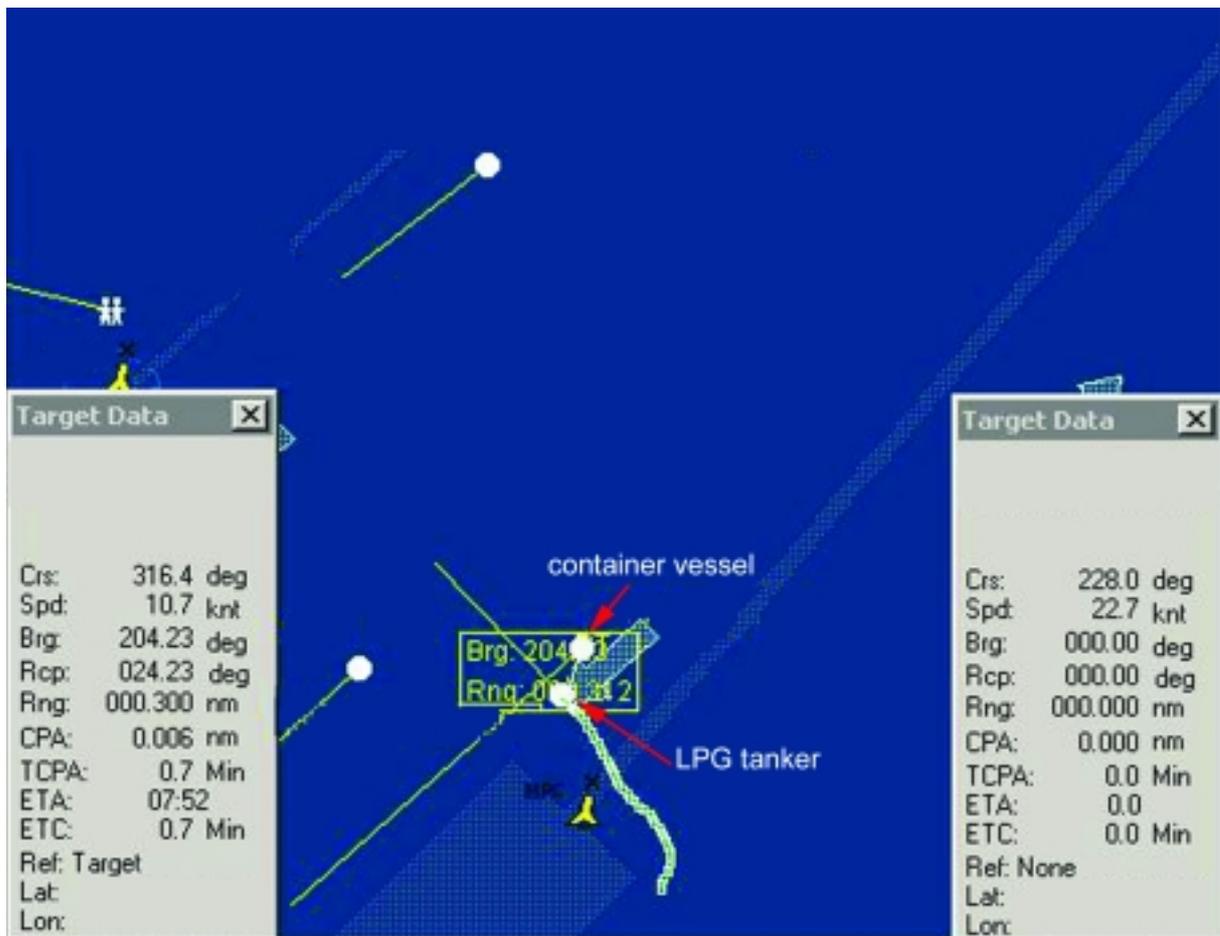
Figure 3: Vessel positions before LPG tanker's turn to port

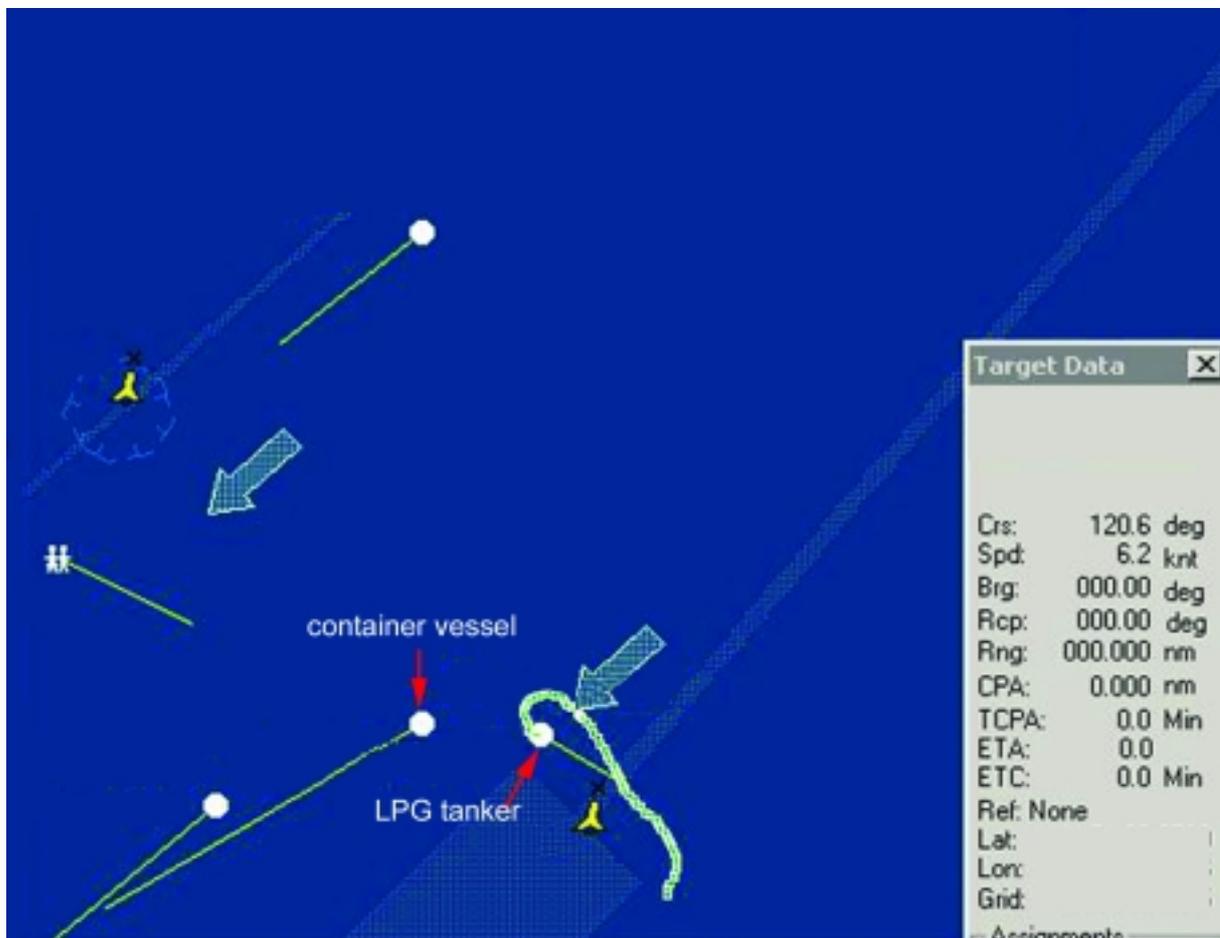
Figure 4: Extent of avoidance action taken by LPG tanker

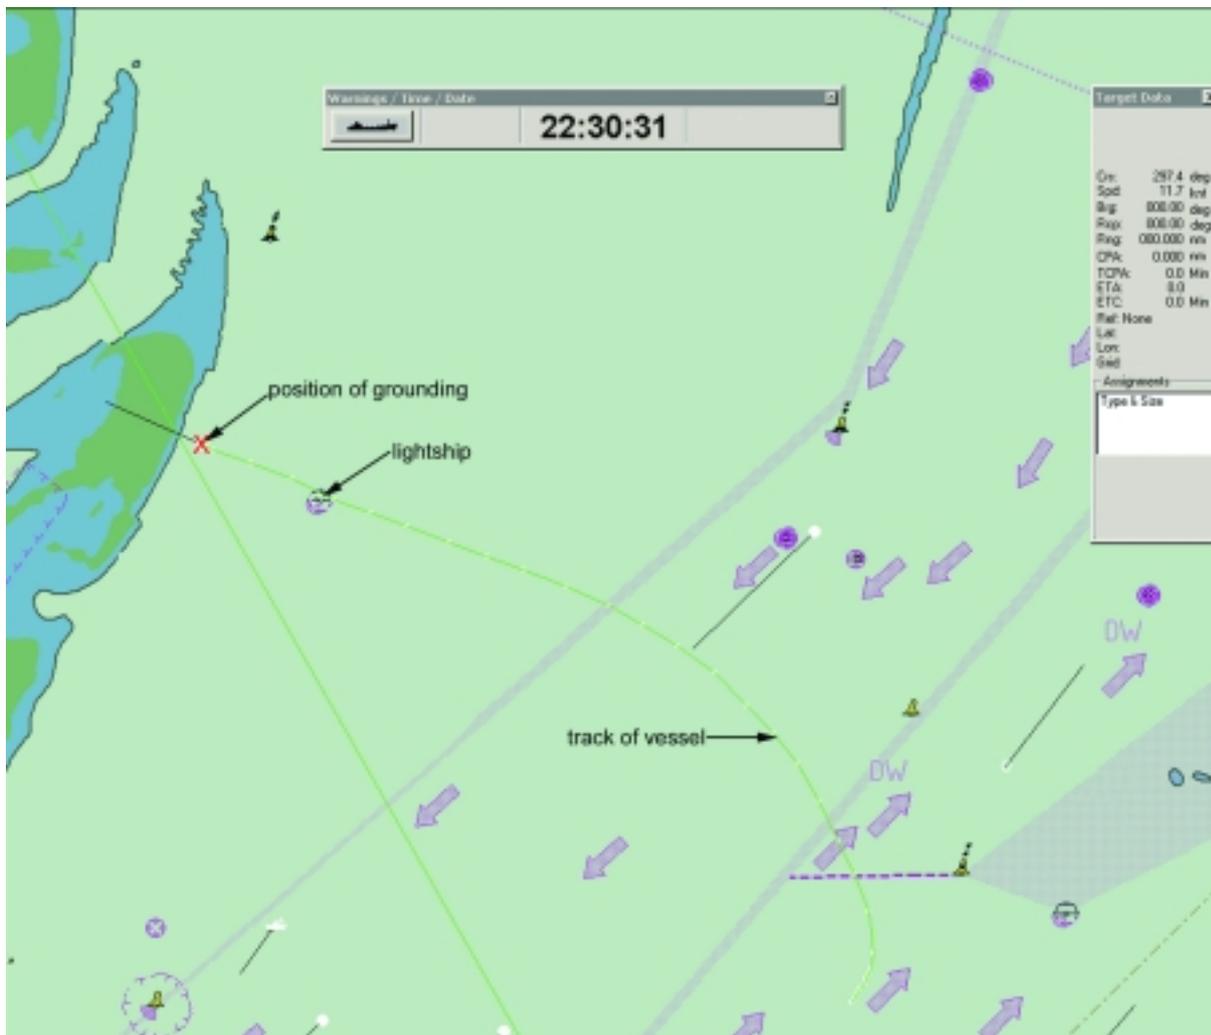
Vessel track until grounding at 2230

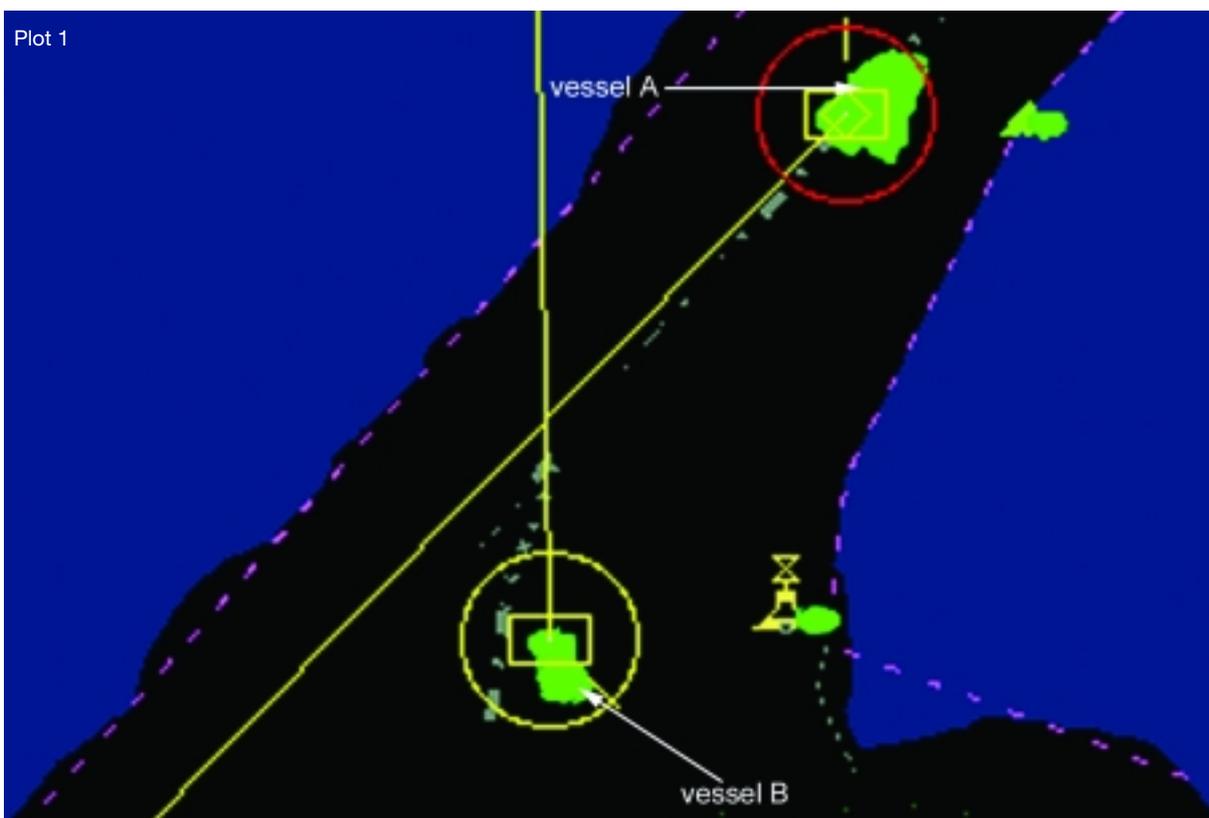
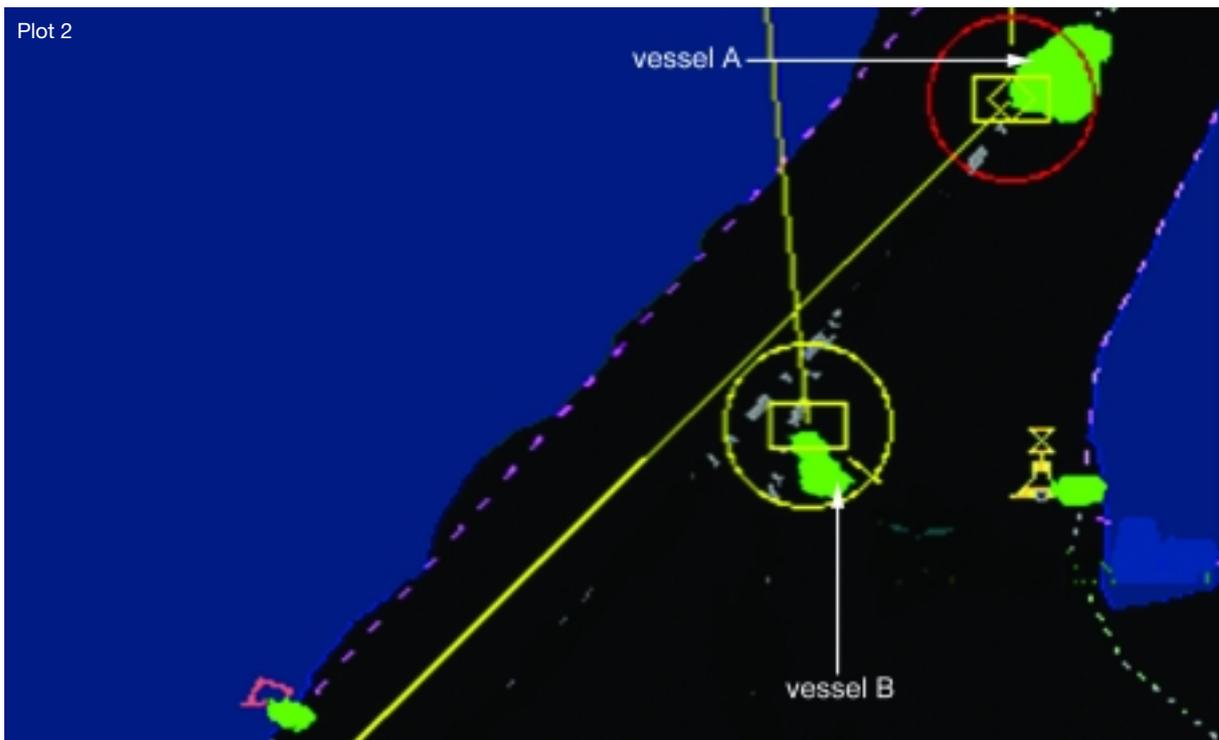
Unaware of the actions of the AB and, in view of the relative aspects of the two vessels, the master of Vessel B assessed that Vessel A must have altered course to port. Consequently, he grabbed the helm and went hard to port (plot 2).

The master of Vessel A was also surprised to see a starboard aspect of Vessel B, and used his forward speed and his side thrusters to slide his vessel away to cushion the effect of the imminent collision. Vessel A suffered minor damage to her hull above the water line and there was paint damage and slight indentation to the bow of Vessel B. Luckily there were no injuries or pollution.

1. This is not the first time a helmsman has put the helm the wrong way in pilotage waters, and it won't be the last. However, such a mistake need not result in an accident, providing it is spotted immediately. Regardless of the experience of those involved, this can only be achieved by the good seamanship practice of habitually checking the rudder angle repeater after each helm order has been given. It will often be too late to rectify the error if the movement of the ship's head is relied upon, particularly in restricted visibility where there are no visual references.
